4. TITLE (and Subtitle) MULTIPLE-PURPOSE PROJECT KANSAS RIVER BASIN REPUBLICAN RIVER MILFORD LAKE OPERATION AND MAINTENANCE MANUAL APPENDIX IV CONSTRUCTION FOUNDATION REPORT		5. TYPE OF REPORT & PERIOD COVERED Construction Foundation Report From June 1962 to Dec 1966

APPENDIX IV
CONSTRUCTION FOUNDATION REPORT

1977
(Revised October 1983)

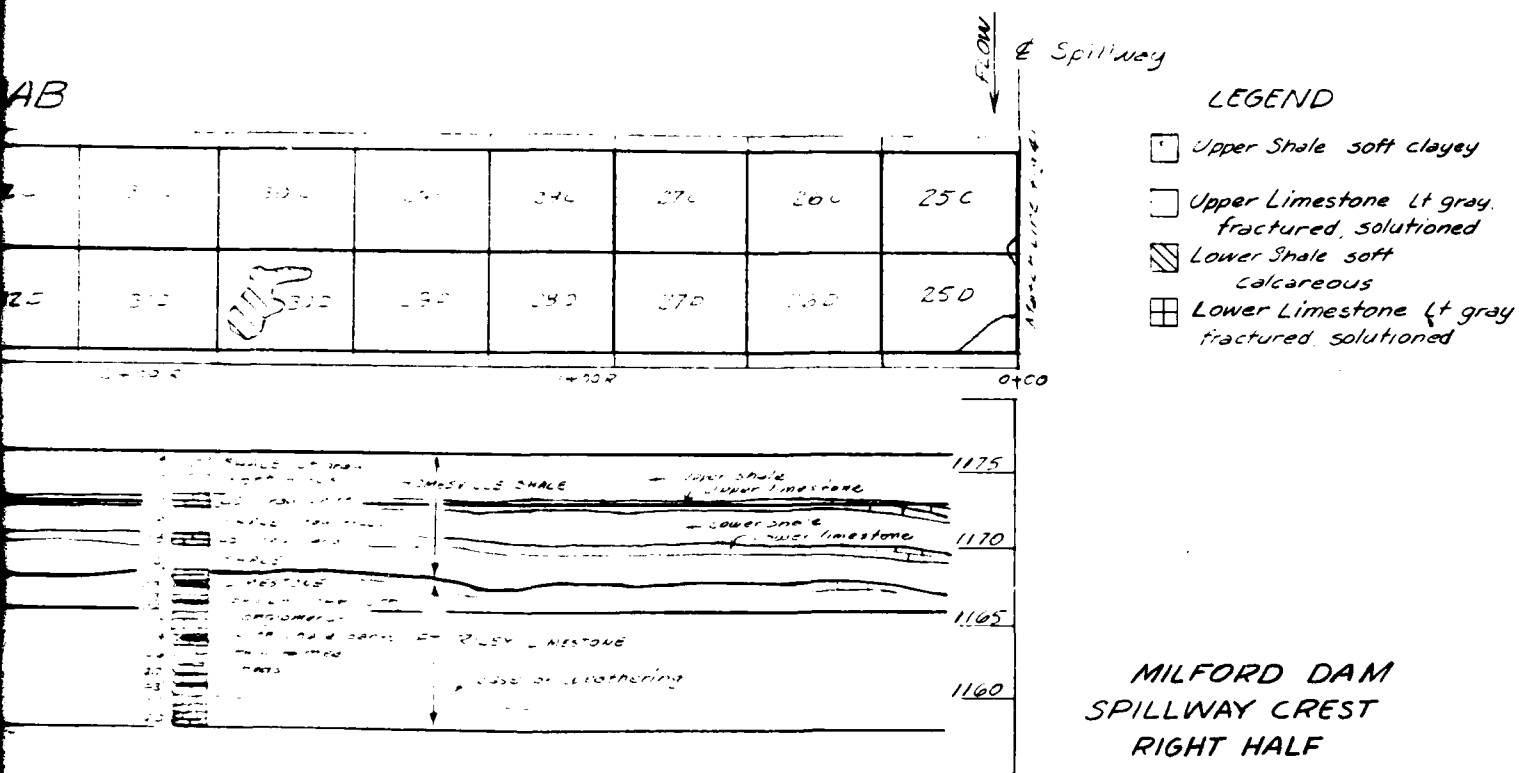
FIGURE 40

5-04. Spillway Sill Foundation. The lower Holmesville shale is the foundation for the crest slab. See foundation map plan and profile spillway, figures 40 and 41. The middle green zone in the south end and the two limestone beds of this member are the foundation toward the north end. For details of the foundation conditions beneath the main sill slab see spillway sill plan and profiles. Foundation of the upper slopes of the sill are Towanda limestone of relatively good quality. Riprap up to elevation 1085 on the north slope and 1083 on the south slope as well as the concrete slabs rest on the upper Holmesville shale.

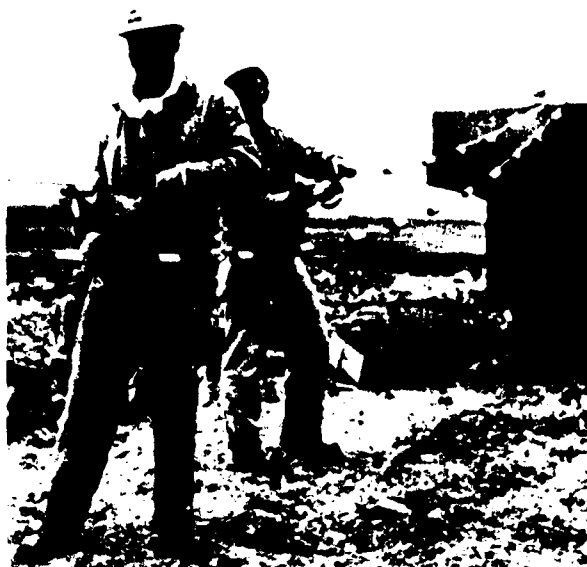
1. Milford Dam,
October 1962,
Neg. No.
294-P4-3.
Laborers making
up "pig tails"
for pre-split
blasting.
